# RAMTECH LABORATORIES, INC.

Re: Class A Classification  
 Laboratory Number 12263/1873

Ramtech Laboratories, Inc., at your request, conducted the Class A Roof Classification Series of roof fire test on Lite Weight Concrete Flat Tile installed on Plastic Battens. The tiles used in the tests were purchased from a distributor by Battens Plus and delivered to Ramtech Laboratories, Inc.

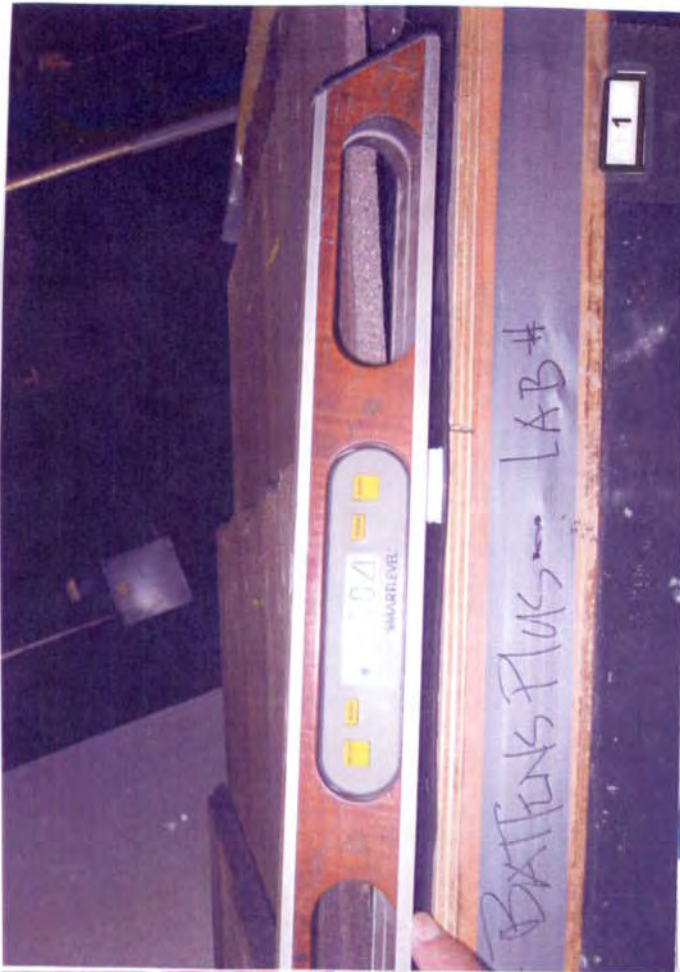
1. Slope of test deck monitored before start of each test. Slope set at 5:12, which is most critical.
2. Ignition sequence of Class A burning brand.
3. Placing the flaming brand on the test deck. Brand placed with the rear edge of the brand 3 inches above the horizontal plywood deck joint.

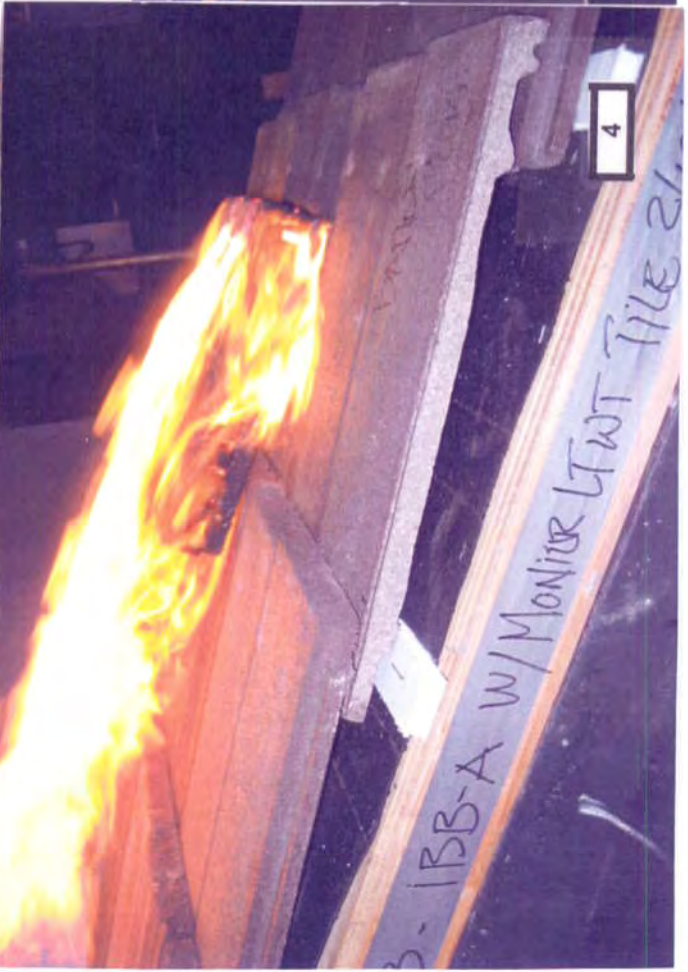
4. View of flaming Class A brand with flame licking past end of deck.
5. View of area between underlayment and underside of concrete tile showing start of melting of the plastic batten.

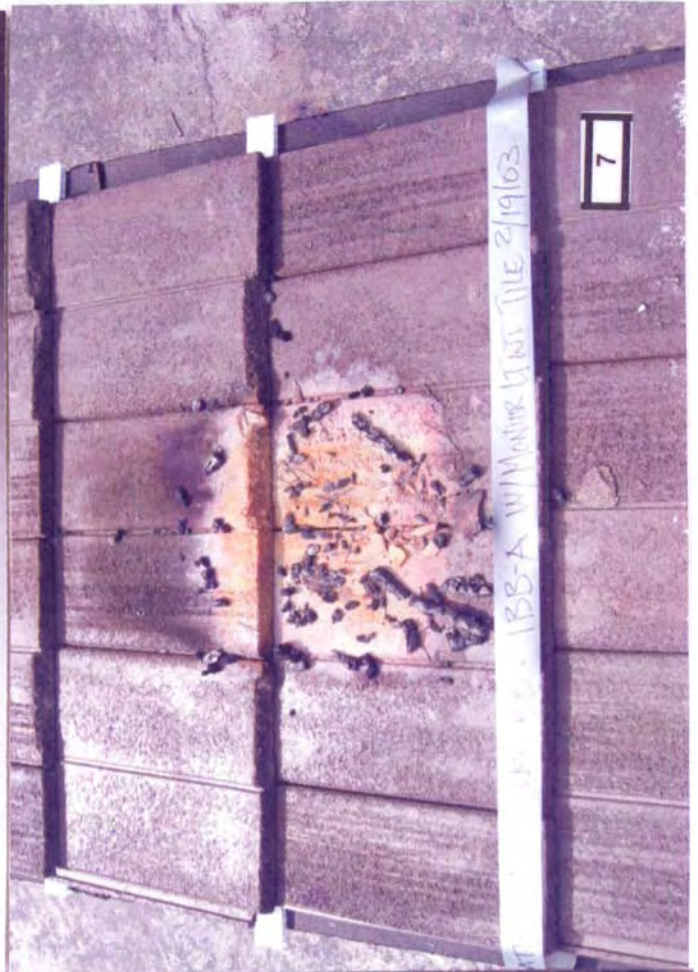
6. Asphalt from underlayment causing stain of plywood joint.
7. Surface condition of concrete tile after Burning Brand test. Note the surface blow off of tile under brand area.

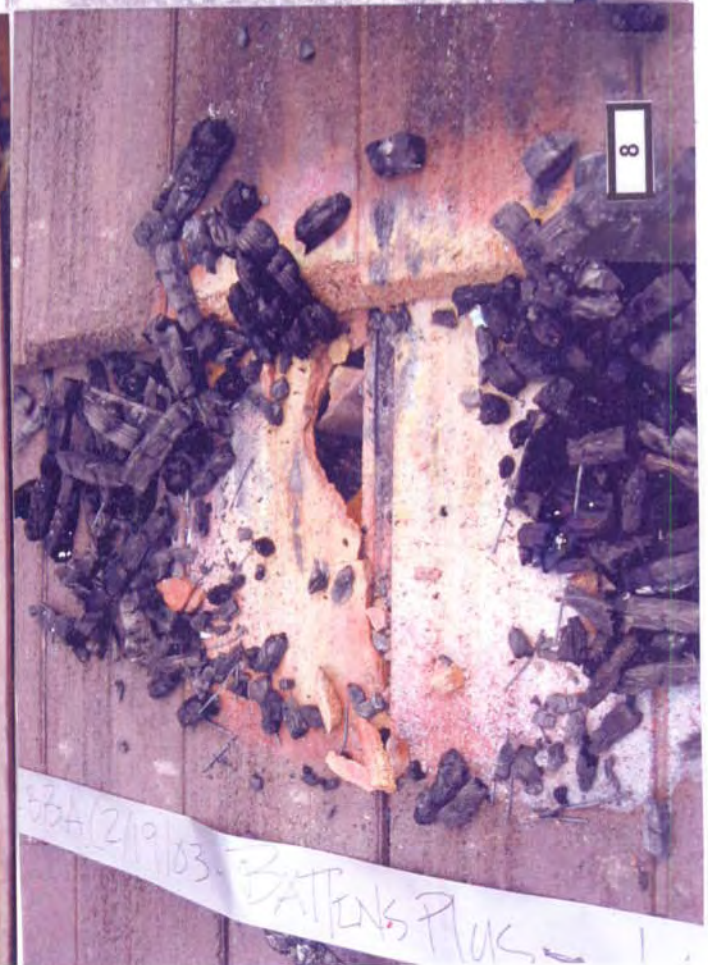
23:00	Test terminated.	
25:00		
30:30		
32:00		
	Tile surface had blowout. Several small pieces of tile found on Underlayment. Battens melted in the heat affected area. All cells closed. Only slight asphalt stain on plywood.	Large hole in tile causing the brand to communicate directly into the cavity. This caused the Underlayment to ignite ultimately causing burn through of plywood.

8. Test No. 2 where Concrete tile blow off caused hole in tile ultimately causing failure of test. Failure of tile prompts testing fifth deck.
9. Backside of Lightweight tile showing the tile section blow off.

Note: Due to failure of MonierLifetile Liteweight tile on Deck 2, Deck 5 will be tested.

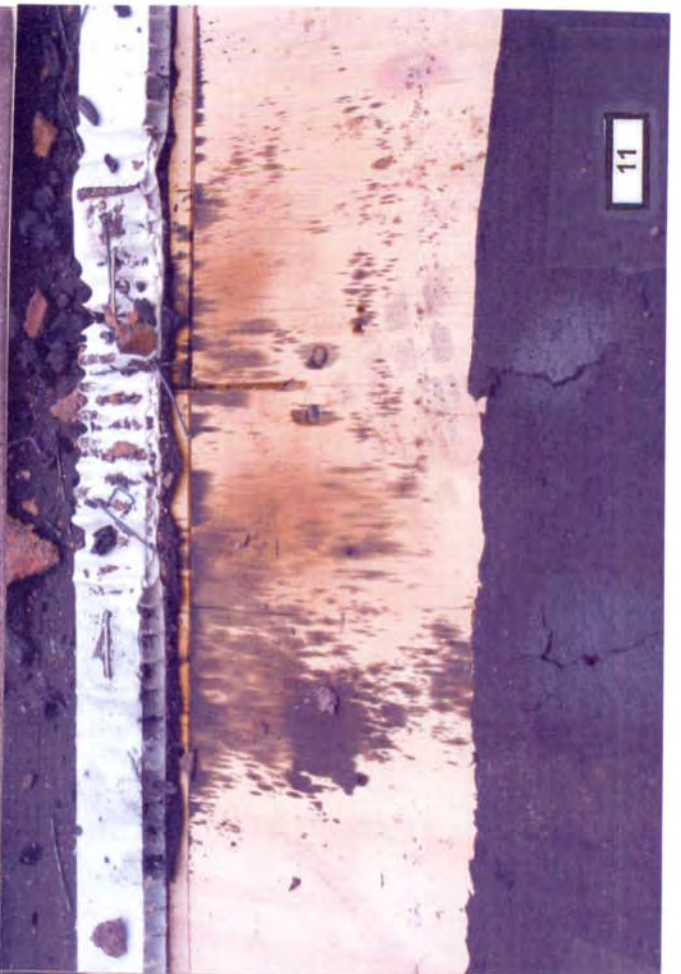
10. Another view of tile surface after completion of test. Tile stayed intact until tile removal operation.
11. Close up of extent of melting of plastic batten. This condition typical.

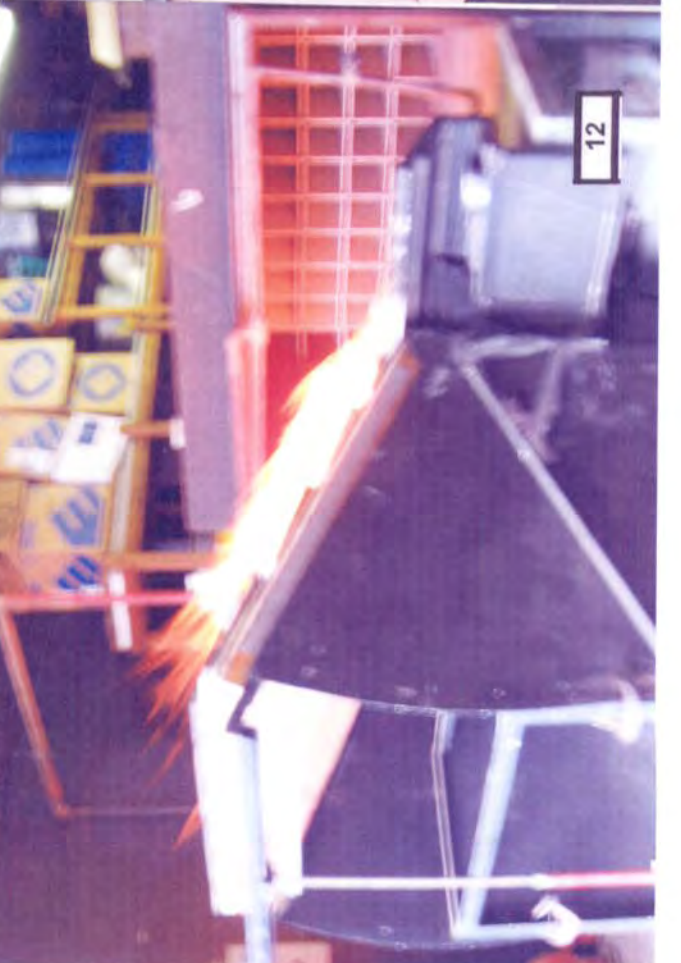
12. Flame pattern of intermittent flame exposure test. Temperature of thermocouple ranged from 1380 degrees F to 1490 degrees F.
13. View of intermittent flame from opposite side.

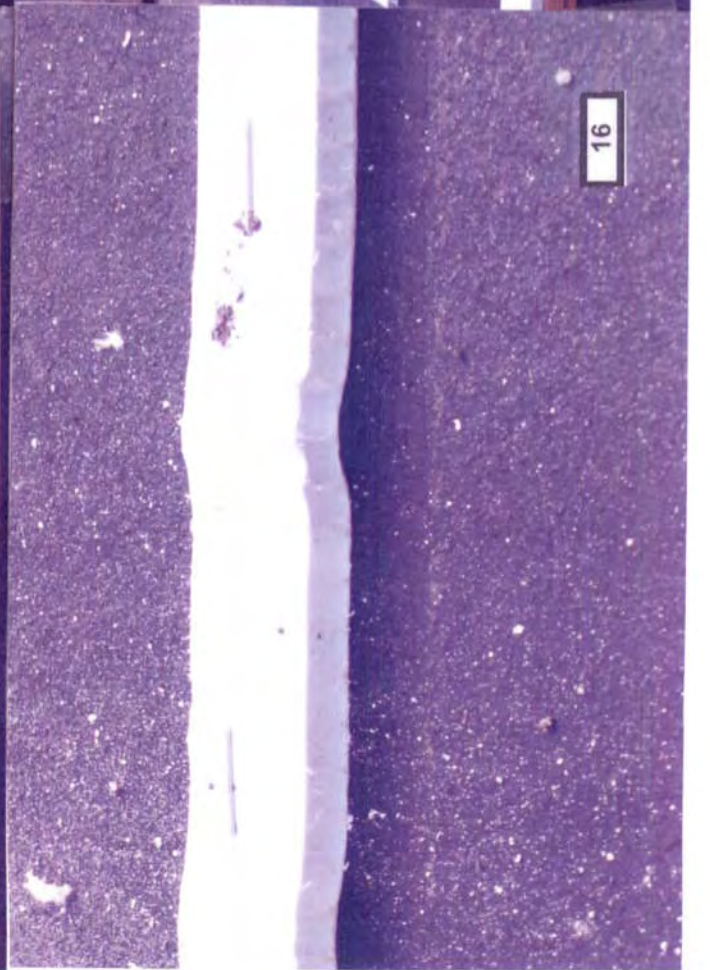
16. Close up of the extent of melting and condition at concrete tile bearing areas after Intermittent Flame Exposure test.
